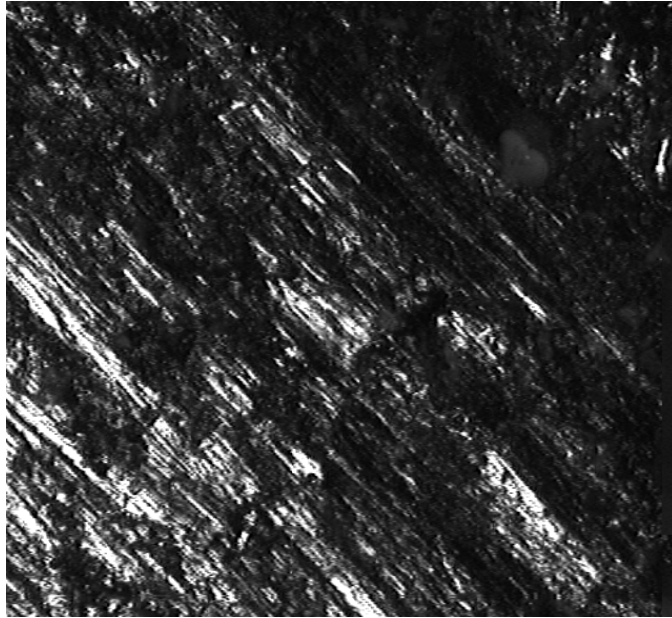
Figure 2.16: Reconstructed image of a metal scratch

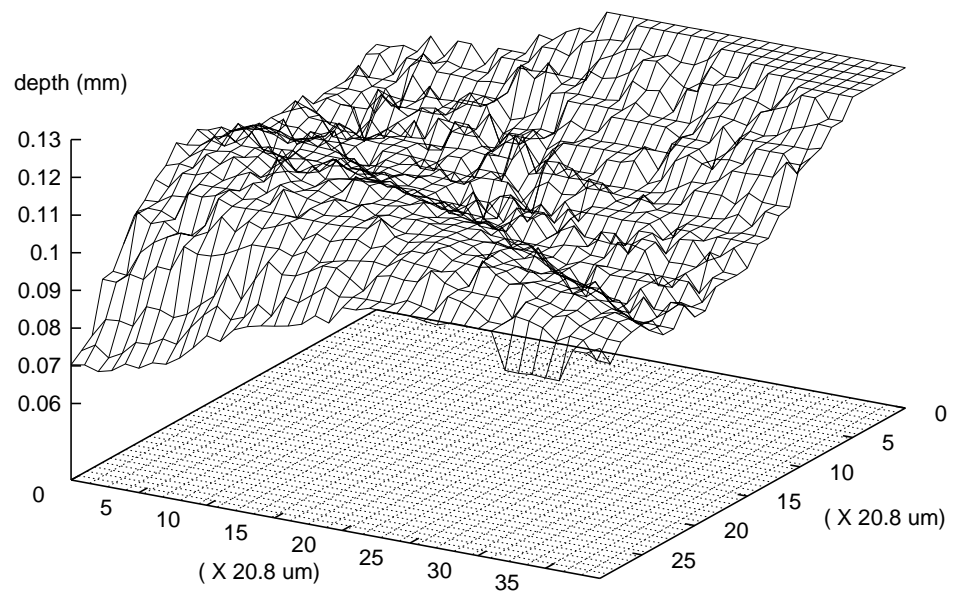
Figure 2.17: Depth map of the metal scratch
